Manhole Inspection Summary

Manhole # S13U__020MH

Insp Date: **1/9/09 9:17 AM**

Location Address: **1027 Wilso Dr.**

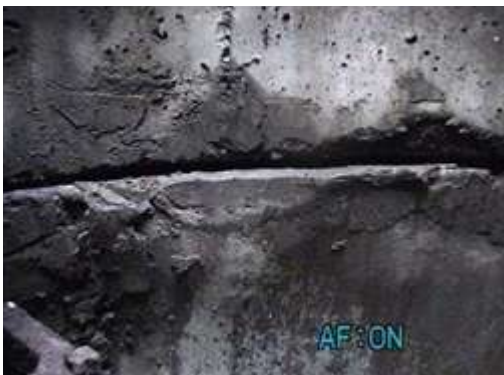
Defect 6

Infiltration: ☐ None ☒ **Joint** ☐ Cracks ☐ Mortar ☐ Roots ☒ **Wall**

infiltration at the corbel and barrel joint

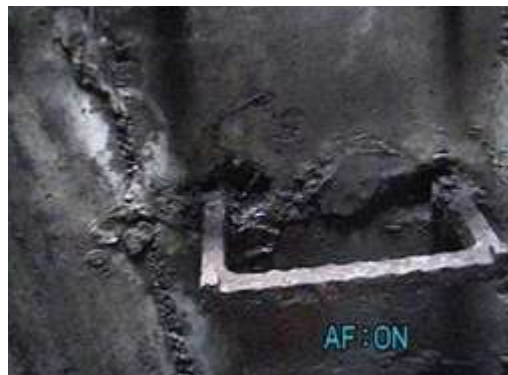
Defect 5

Condition: ☐ Sound ☒ **Cracked** ☐ Root Intrusion ☐ Loose Brick ☐ Deteriorated

cracks in the corbel causing infiltration

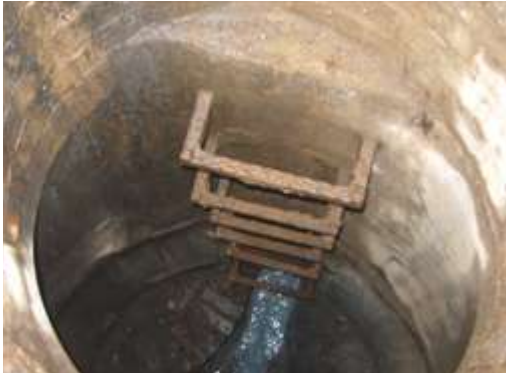
Defect 4

Count: **6** Missing: **0** ☒ **Corroded**

corroded rungs

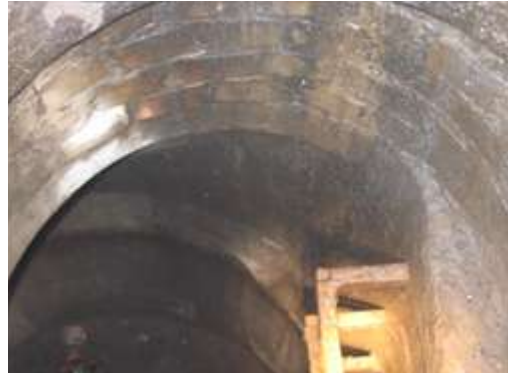
Defect 3

Infiltration: ☐ None ☒ **Joint** ☐ Cracks ☒ **Mortar** ☐ Roots ☐ Wall

chimney and corbel infiltration

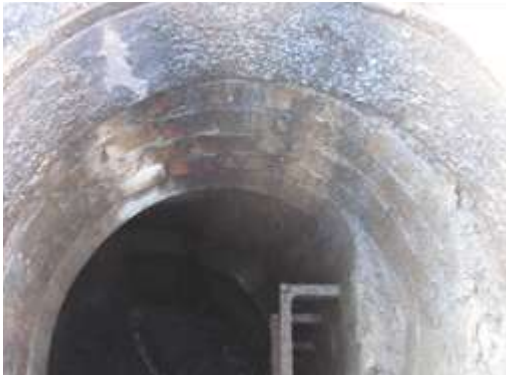
Defect 2

☒ **Leaks**

frame infiltration

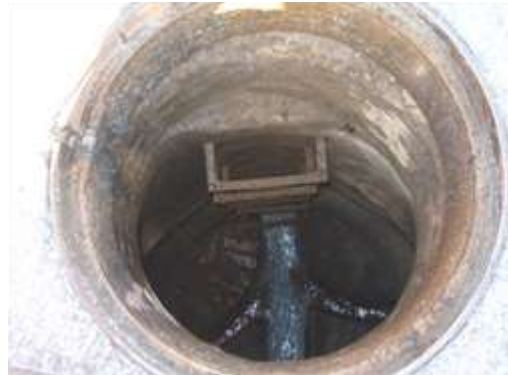
Defect 1

Offset: **2** (in.)

☒ **Cracked**

cracked frame offset

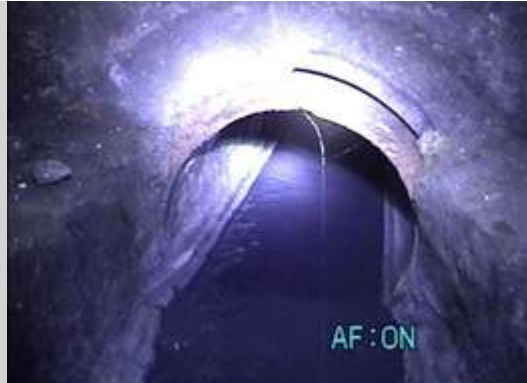
12 O'Clock Outflow

8 in. Circular Gravity Sewer
Pipe Out @ 12 O'Clock

Pipe Height: **8.4** (in.) Rod and Bar (Angled)
Pipe Material: **Clay** ☐ Pipe Lined
Invert Depth: **9.80** (ft.) Flow Characteristics: **Fast**
Deposits: ☒ None ☐ Mud ☐ Sludge ☐ Debris ☐ Grease
Silt Depth: **0** (in.) Deposits Extent:
Infiltration: **None** Pipe Seal Cond: **Sound**

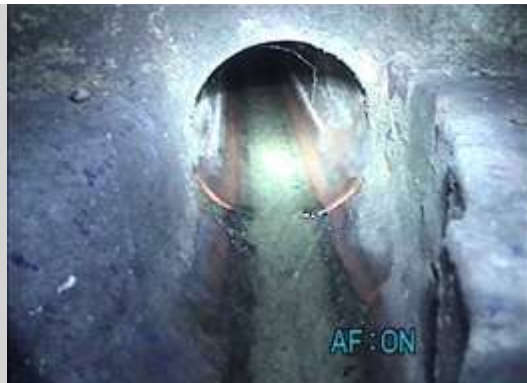
3 O'Clock Inflow

6 in. Circular Gravity Sewer
Pipe In @ 3 O'Clock

Pipe Height: **6** (in.) Rod and Bar (Angled)
Pipe Material: **Clay** ☐ Pipe Lined
Invert Depth: **9.60** (ft.) Flow Characteristics: **Slow**
Deposits: ☒ None ☐ Mud ☐ Sludge ☐ Debris ☐ Grease
Silt Depth: **0** (in.) Deposits Extent:
Infiltration: **None** Pipe Seal Cond: **Sound**

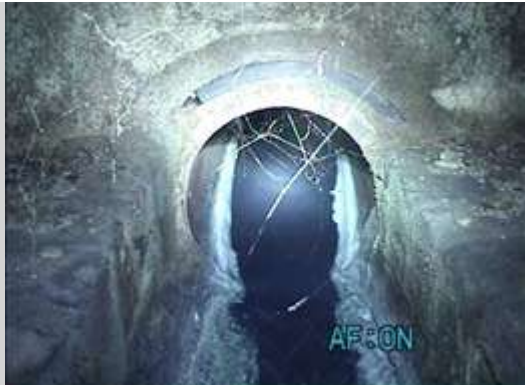
6 O'Clock Inflow

8 in. Circular Gravity Sewer

Pipe In @ 6 O'Clock

Infiltration: **None** Pipe Seal Cond: **Sound**

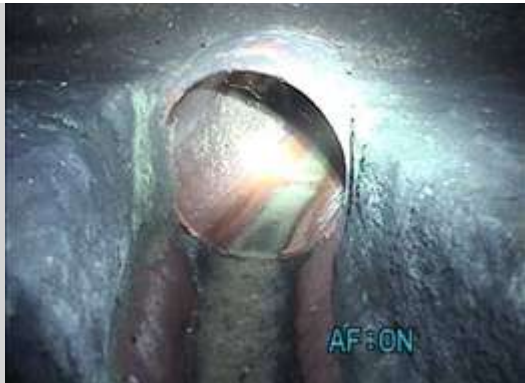
9 O'Clock Inflow

6 in. Circular Gravity Sewer

Pipe In @ 9 O'Clock

Infiltration: **None** Pipe Seal Cond: **Sound**
